# EVANS ROOFING CASE STUDY

### The Salvation Army Building Ardmore, OK

#### **Roofing System**

Versiweld® 60 mil TPO

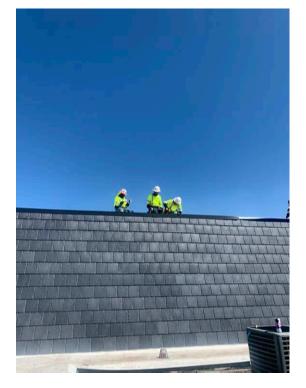
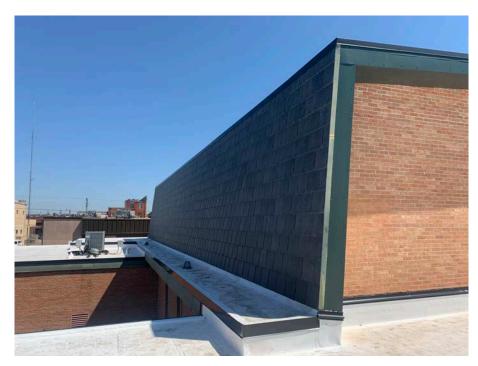
The Sanctuary needed to be re-roofed. The old slate shingles needed to be removed. The roof had an 20/12 pitch. Therefore, workers needed to be working from a platform in order to be safe and comfortable.

After tear off, we made necessary decking repair installed the underlayment. Then the Davinci Roofscapes Belforte slate shingles were installed.
